## **RED Flag 9C070095**

Carried: PONY FARM ROAD Crossed: DELAWARE & HUDSON

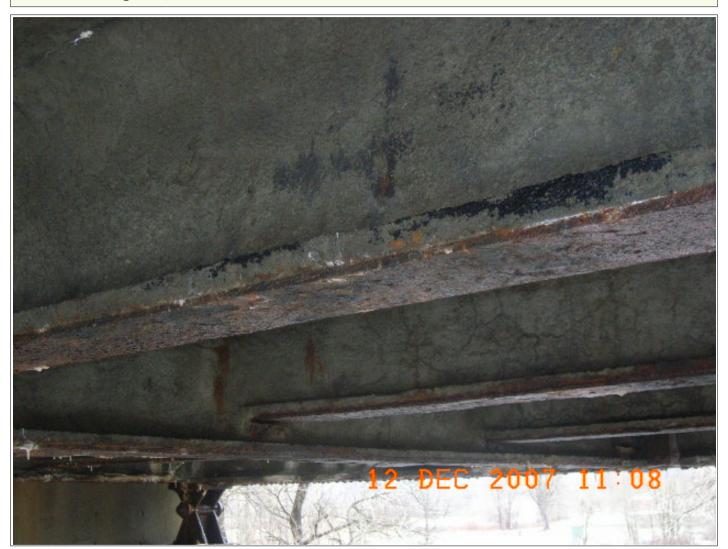
Panel 2 Stringer 3, Left Side

RED STRUCTURAL FLAG 9C070095 Issued (No Previous Flag Superseded):
In Span 3, the bottom flanges of almost all Stringers exhibit heavy rust scale with
 section losses at their centers. Losses are estimated based a combination of caliper
readings of exposed flange edges, pitting depths, and visual comparisons, as follows:
 Panel 1 - S1: 20% S2: 20%
                                S3: 10%
Panel 2 - S1: 20% S2: 20% S3: 15%
 Panel 3 - S1: 30% S2: 40% S3: 20%
Panel 4 - S1: 35% S2: 45% S3: 30%
 Panel 5 - S1: 30% S2: 20%
                                S3: 15%
 Panel 6 - Minimal Losses.
Stringers are classified Load Path Redundant. Webs and top flanges are encased and
likely to have only minimal losses. Some slight variations in losses were observed, but
no distress or excess deformation is evident.
Upon QC review it was determined that the condition of the Stringers warrants a RED
Flag, as it represents > 1/3 flange loss to adjacent redundant members.
