## RED Flag 9C070093

Carried: PONY FARM ROAD Crossed: DELAWARE &amp; HUDSON

BIN: 2227870 Carried: PONY FARM ROAD Crossed: DELAWARE &amp; HUDSON

RED STRUCTURAL FLAG 9C070093 ISSUED (Flag 9W060016 superseded):

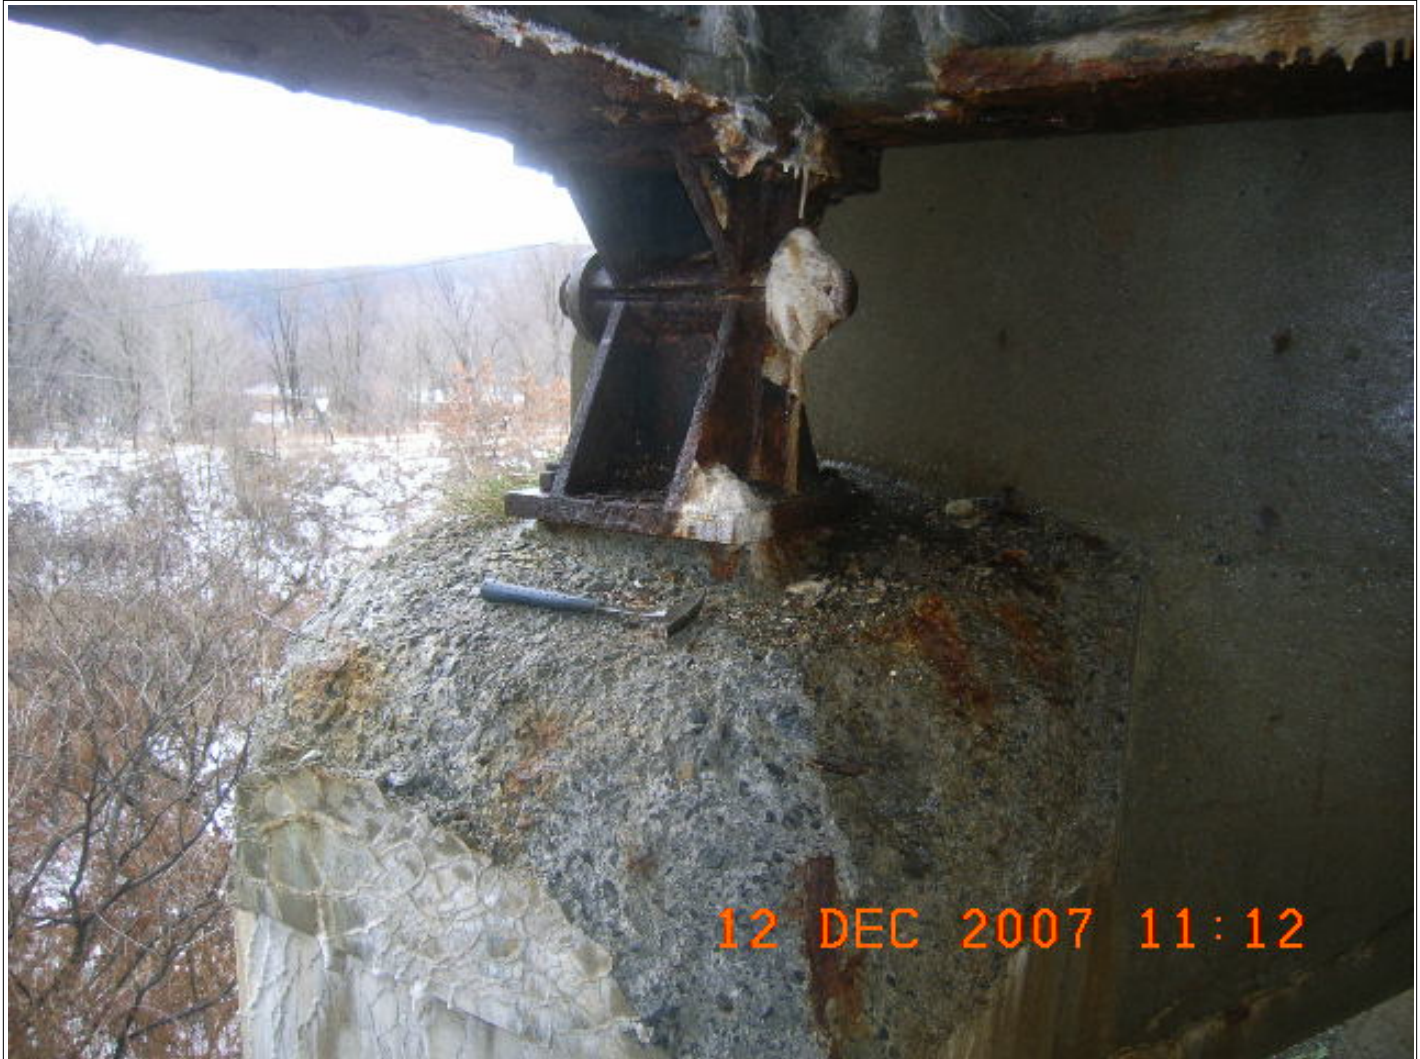
07-1476.jpg - Attached to RED Flag 9C070093

The SPAN 2 RIGHT Pedestal exhibits crumbly concrete, with undermining along the front face of the Bearing up to 2.5 in. for Span 3 G2. The undermining reduces the bearing area by approximately 14%, which is a slight increase from the previous inspection (12%). The Pedestal is spalled up to 6 in. deep, with up to an additional 1 in. depth of crumbly concrete. The Right Pedestal has been included in this flag to show the condition of the overall load transferring system of superstructure to the substructure.

Left End Side of Right Column of Pier 2

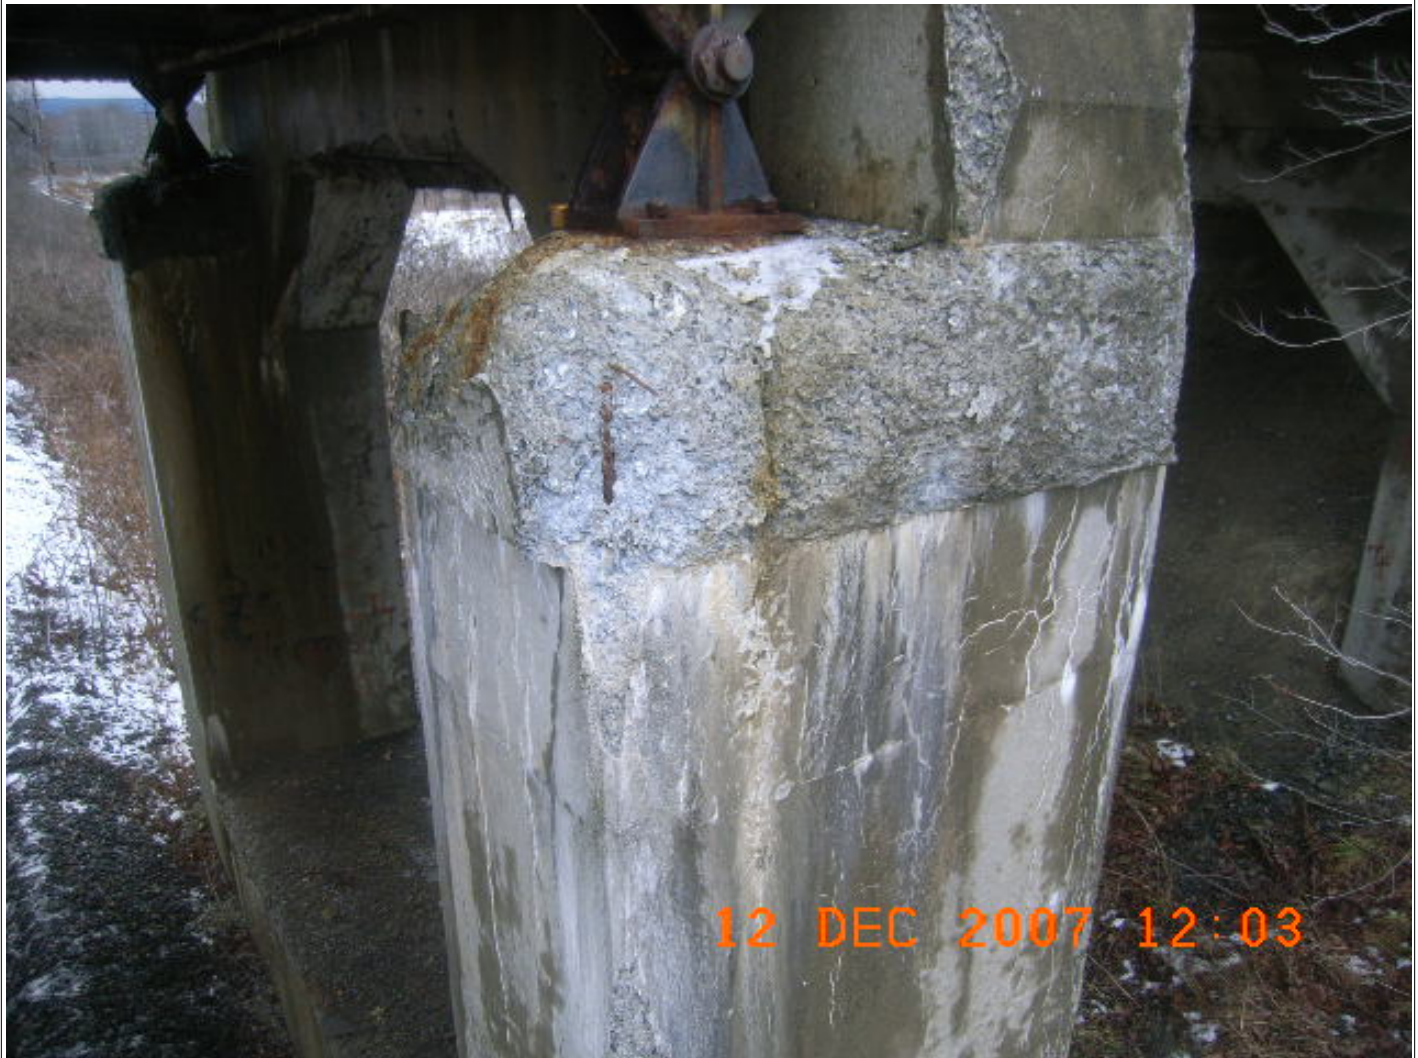
07-1480.jpg - Attached to RED Flag 9C070093

The SPAN 2 LEFT Pedestal exhibits crumbly concrete, with a fracture line extending through the Begin ("rear") anchor bolts of the Bearing reaching a maximum length of 5 ft. down the side of the Pier Column with thick efflorescence extending another 1 ft. The entire Pedestal surface is spalled up to 8 in. deep, with crumbly concrete extending at up to 1 in. into the remaining material. Cleaning of loose material reveals a line of deeper deterioration, with a crack evident through both cement paste and aggregate. The crack appears to be a product of general deterioration rather than active shear failure of the concrete. But it forms a plane of weakness which effectively undermines 95% of the Bearing. No significant change to this condition as well as no sign of movement or settlement were observed this inspection. Vertical rebars with minor section losses were noted in the column/pedestal concrete.

Left Side of Left Column of Pier 2
